# Boutique Aircraft Restoration

## 1940 Tiger Moth Project

## 1958 Cessna 172 B Project

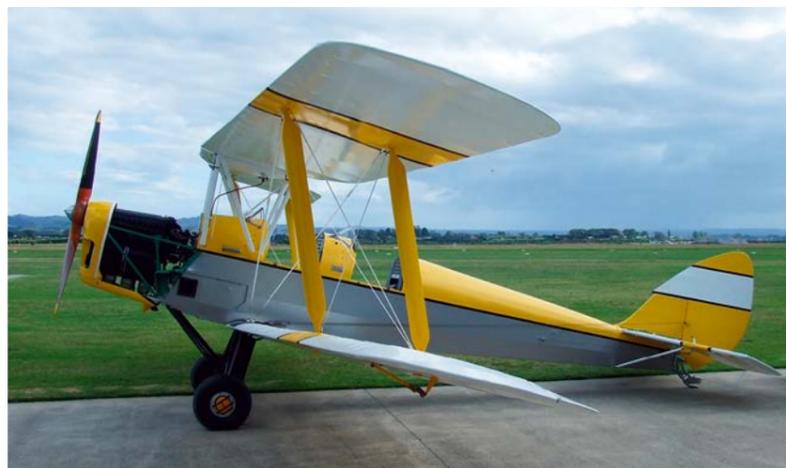
Top: ZK-BAL making its first post-restoration appearance outside the hangar at Pacific Aero Coatings prior to engine tests. Left: Flying at Gisborne. Right: Refurbished instrument panel.

ZK-BAL left Pacific Aero Coatings and returned to Gisborne in July of 2012 and has been in regular use and much enjoyed by her syndicate owners since then.

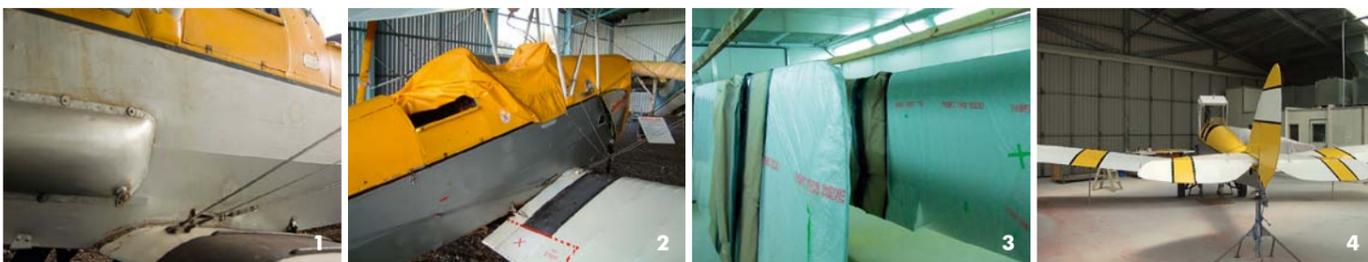
In 2012, BAL was brought to the Pacific Aero Coatings hangar at Tauranga to have 'crazy cracks' repaired in her fabric in order to then be inspected for a CoA. The reality was that all of the fuselage fabric was on its 'last legs' – Kim in fact put his hand right through some of it during inspection tests. The intention then became that the fuselage be re-bagged so that a CoA could be obtained.

However, on removing the fabric, they typically discovered a host of other issues including corrosion that may well have been creeping away since top dressing days. This all needed to be addressed and after consultation with the syndicate members, the project turned into a restoration. Thus the aircraft remained in Pacific Aero Coatings' hangar whilst the restoration was completed over a 12 month period as syndicate funds permitted.

1&2: Pre restoration. 'Crazy cracks' were present in the paint everywhere. 3: Wings masked for the black stripes. 4: Nearing completion during re-assembly.

BAL's wings had already been re-fabricated as part of earlier repairs and this work stood up to testing processes, so Pacific Aero Coatings' involvement was initially to strip and replace all of the fuselage fabric. All of the airframe was then corrosion treated and painted, and the tail feathers were also replaced. Various wood components were either restored or replaced and all flying wires were tested, treated and painted. Corrosion in the mainstays was also fixed. The instrument panels were refurbished and cracks were repaired in the engine cowls, the only item not attended to during Kim's work being the engine which was still performing well.

The whole aircraft was then repainted to its original colour scheme. Kim says that this was in fact quite a process, involving yellow, black, green, white and silver. Aviation certified Superflite paint systems were used, being Superflite dope on fabric and Superflite System 6 urethane on all of the metal componentry.

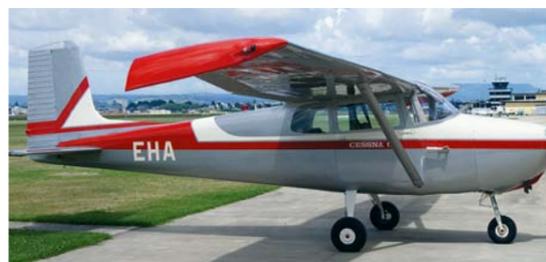
Ready for another 50 years. EHA in the sun at Tauranga.

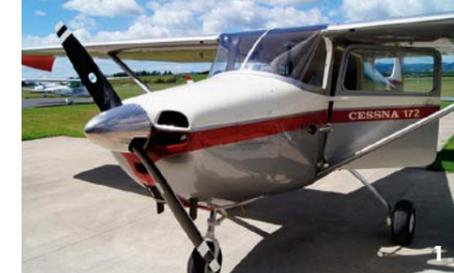
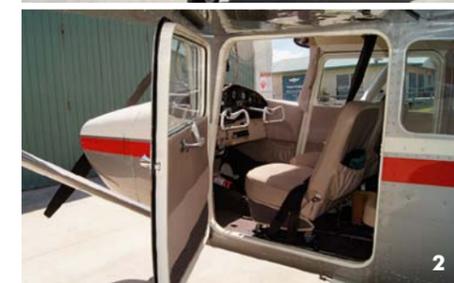
**Captions**  
1&2: Fully restored inside and out.  
3&4: On arrival at Pacific Aero Coatings, in "well-used" condition.  
5: Only aviation certified water-soluble paint strippers are used, with non-aggressive removal methods to ensure panels are not damaged or distorted.  
6: Hail damage is clearly evident on the upper wing surfaces.  
7: Wing sections inside the spray booth for painting.

all of the gremlins hiding under the existing finish were exposed – noting that what can be seen on top of the paint is often nothing compared to what is hiding beneath it. As expected, EHA did indeed have major corrosion issues to the extent that some panels were completely replaced with the assistance of FlightCare at Tauranga. Along with complying with all Cessna SIDs during the process, they discovered the undercarriage was holding on by a “mere fraction” of the original fittings and structure.

After paint was stripped, bare surfaces were bead blasted to remove all traces of corrosion.

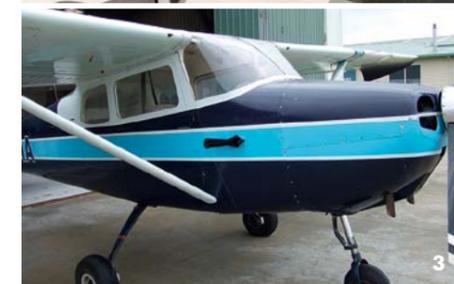
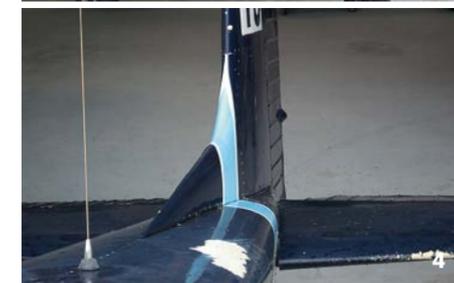
When EHA arrived at Pacific Aero Coatings, the interior had already been attended to, so in this case Kim's work was limited to all of the aircraft's surfaces and external presentation. Kim kindly describes the appearance and condition on arrival as "well used".
