# Aircraft Fabric Spoken Here

*Fabric covered aeroplanes are old, modern, beautiful and durable. But where does one turn for repair or restoration support? KiwiFlyer recently spoke with Paul Waterhouse of Central Aero Engineering to help readers demystify the subject.*

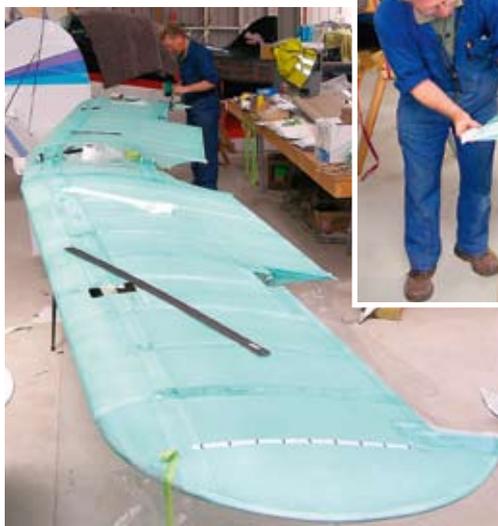
Colin Sutherland reinforces the wing tip area prior to applying further fill and finish coats of butyrate dope.

with dope applied by brush. If you want a higher level of finish then sand it smooth and spray the dope on. A ding or tear may require a bit of glue, a fabric patch and some paint. Wingtips attract 'hangar rash' and are often an area of constant repair.
