The Beaver's New Clothes

Ensuring authenticity

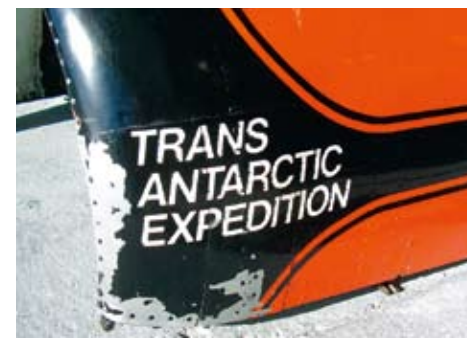
There was plenty of wear and tear on the existing paint scheme

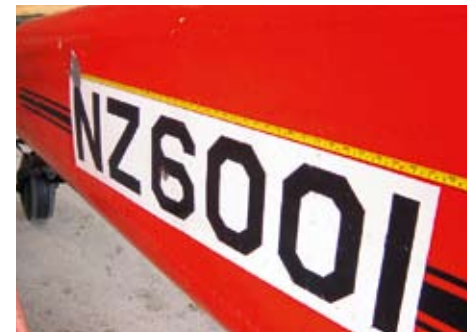
Locations and dimensions of all markings were recorded with photographs and drawings.
