# The Beaver's New Clothes

### Ensuring authenticity

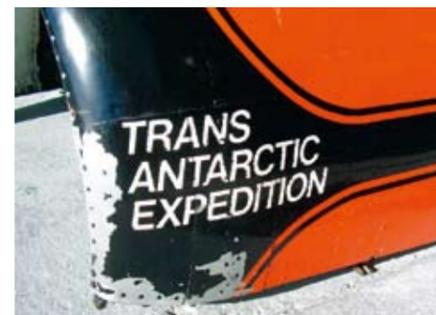
There was plenty of wear and tear on the existing paint scheme

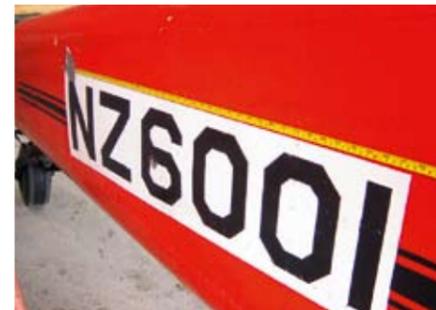
Locations and dimensions of all markings were recorded with photographs and drawings.
